**Flood Control Project Maintenance  
Levee Inspections**

## Maintenance Issue Types Only, Levee Inspection Report By Mile - Spring 2016

### Reclamation District No. 1500 Sutter Basin

Waterway	Bank	Unit Miles	Inspection Start/End	Inspector
Unit No. 01 Sacramento River	Left	33.15	03/09/2016 03/10/2016	Jai Lor

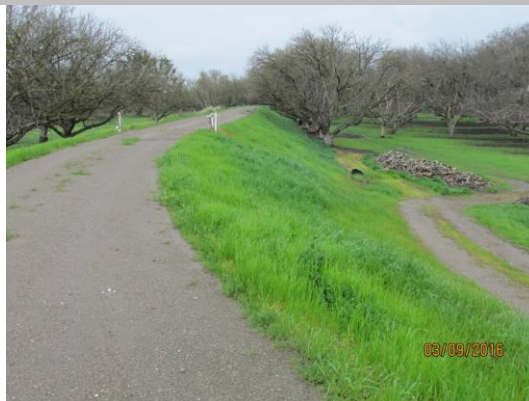
Photo 1 of 1 : SP\_2016\_RD1500\_189\_123\_20160317\_00246.jpg

LM Start	0.00	Rating **	M	Issue No.	123
LM End	30.66	Issue Type +	Ma	Location *	LS
Category	Earthen Levee			GPS Latitude/Longitude	
				Start	End
Item	Vegetation			38.761055 °	39.000635 °
				-121.674675 °	-121.801345 °
DWR ID	DWR_RD1500_01_s_2016_123				
Comment Code					
V1 : Control annual grass and weeds on the levee slopes and easements.					
Inspector Comment

View of the vegetation on the landward side of the levee looking upstream. Spring 2016.

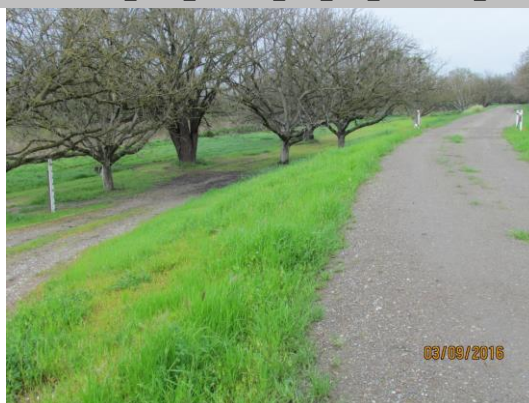
Photo 1 of 1 : SP\_2016\_RD1500\_189\_124\_20160317\_00247.jpg

LM Start	0.01	Rating **	M	Issue No.	124
LM End	31.63	Issue Type +	Ma	Location *	WS
Category	Earthen Levee			GPS Latitude/Longitude	
				Start	End
Item	Vegetation			38.761020 °	39.006444 °
				-121.674870 °	-121.816475 °
DWR ID	DWR_RD1500_01_s_2016_124				
Comment Code					
V1 : Control annual grass and weeds on the levee slopes and easements.					
Inspector Comment

View of the vegetation on the waterward side of the levee looking upstream. Spring 2016.

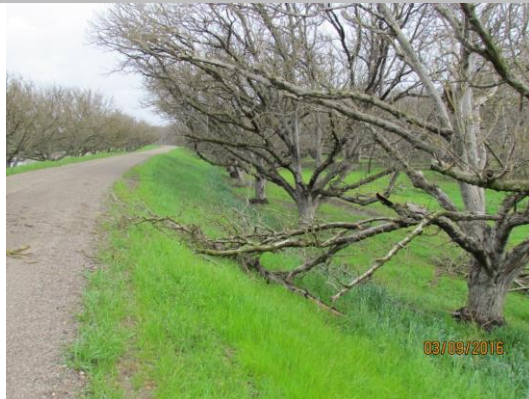
Photo 1 of 1 : SP\_2016\_RD1500\_189\_126\_20160317\_00248.jpg

LM Start	0.19	Rating **	M	Issue No.	126
LM End	0.19	Issue Type +	Ma	Location *	LS
Category	Earthen Levee			GPS Latitude/Longitude	
				Start	End
Item	Trim / Thin Trees			38.761650 °	38.761650 °
				-121.677950 °	-121.677950 °
DWR ID	DWR_RD1500_01_s_2016_126				
Comment Code					
T1 : Trim trees to at least five feet above ground level.					
Inspector Comment					
Tree branches are broken and on the levee slope.

View of the broken tree limb on the landward side of the levee looking upstream. Spring 2016.

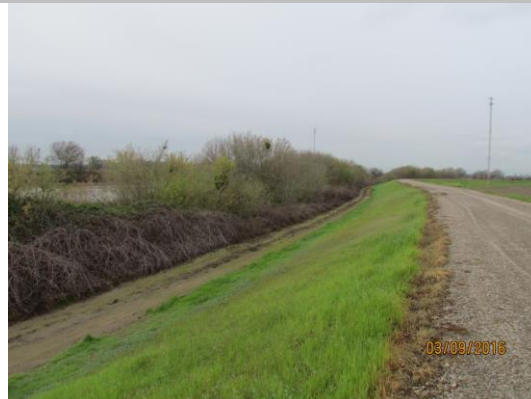
Photo 1 of 2 : SP\_2016\_RD1500\_189\_72\_20160317\_00249.jpg

View of the revegetation site on the waterward side toe of the levee looking upstream. Spring 2016.

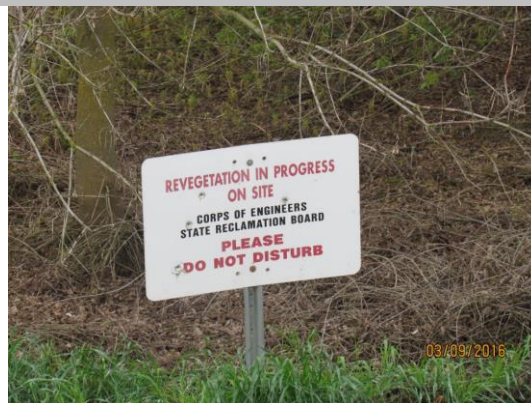
Photo 2 of 2 : SP\_2016\_RD1500\_189\_72\_20160317\_00250.jpg

Sign is located at the toe of the levee on the waterward side. Spring 2016.

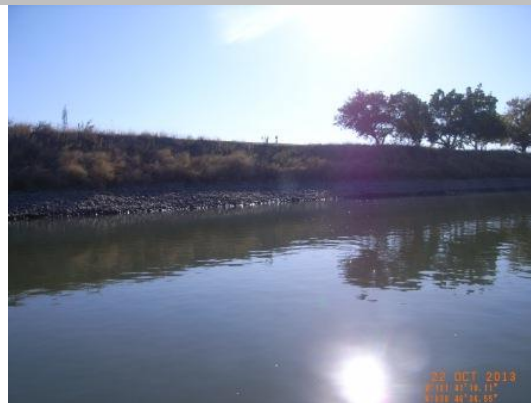
Photo 1 of 1 : SP\_2016\_RD1500\_189\_6\_20160304\_00006.jpg

LM Start	1.34	Rating **	A/W	Issue No.	6
LM End	1.95	Issue Type +	Ma	Location *	WS
Category	Supplemental			GPS Latitude/Longitude	
				Start	End
Item	2015 USACE Erosion Survey, DRAFT			38.770390 °	38.777282 °
				-121.690553 °	-121.685841 °
DWR ID	DWR_RD1500_01_s _ 2016_6				
Comment Code					
Inspector Comment					
2006 - New erosion upstream, new bank failures near levee but still fairly wide berm in most places. 2008 - Large berm, questionable as to if it should remain in the inventory. 2010 - Minor new erosion, old cobble starting to fail. 2011 - Cobble continues to unravel and additional slumping. 2012 - Minor new erosion at bank mid point. 2013 - Minor new erosion. 2015: No observed changes. [2015 Site ID: SAC 86-3 L]

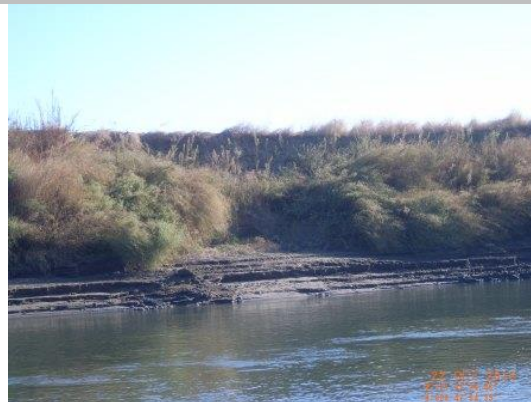
Photo 1 of 1 : SP\_2016\_RD1500\_189\_2\_20160304\_00002.jpg

LM Start	2.30	Rating **	A/W	Issue No.	2
LM End	2.52	Issue Type +	Ma	Location *	WS
Category	Supplemental			GPS Latitude/Longitude	
				Start	End
Item	2015 USACE Erosion Survey, DRAFT			38.781962 °	38.784936 °
				-121.688033 °	-121.690033 °
DWR ID	DWR_RD1500_01_s _ 2016_2				
Comment Code					
Inspector Comment					
2010 - The upstream end of the repair site at 87.0. Repair did not extend far enough upstream. 2011 - New erosion pockets. 2012 - Minor new erosion at toe. 2013 - Minor new erosion. 2015: Significant new toe erosion. [2015 Site ID: SAC_87-1_L]

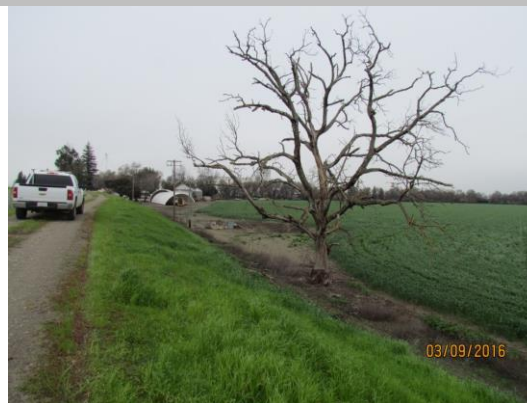
Photo 1 of 1 : SP\_2016\_RD1500\_189\_1340\_20160317\_00259.jpg

View of the dying tree on the landward side of the levee looking upstream. Spring 2016.

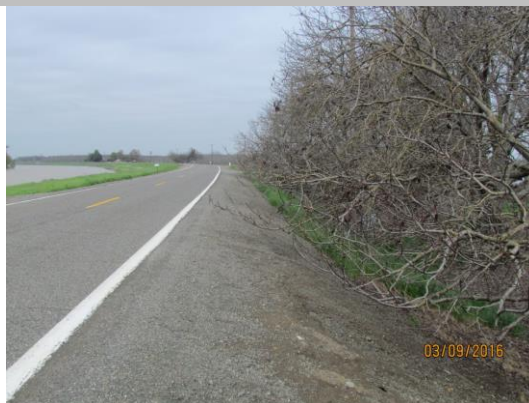
Photo 1 of 1 : SP\_2016\_RD1500\_189\_217\_20160317\_00264.jpg

View of the trees on the landward side of the levee looking upstream.  
Spring 2016.

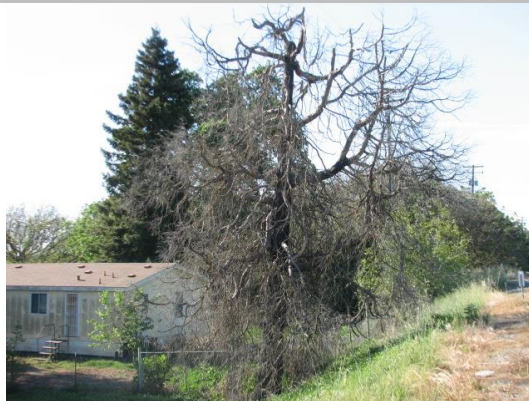
Photo 1 of 1 : SP\_2016\_RD1500\_189\_1343\_20160304\_00098.jpg

Monitor tree that may pose a future threat to the integrity of the levee.  
Spring 2014

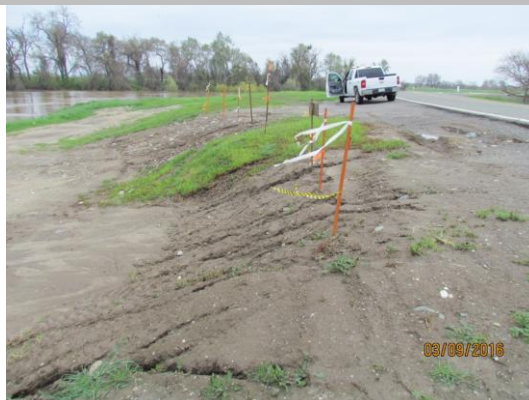
Photo 1 of 1 : SP\_2016\_RD1500\_189\_150\_20160317\_00266.jpg

LM Start	8.29	Rating **	M	Issue No.	150
LM End	8.29	Issue Type +	Ma	Location *	WS
Category	Earthen Levee			GPS Latitude/Longitude	
				Start	End
Item	Erosion / Bank Caving			38.838802 °	38.838802 °
				-121.729598 °	-121.729598 °
DWR ID	DWR_RD1500_01_s _ 2016_150				
Comment Code					
E2 : Schedule repair of erosion site prior to the next inspection.					
Inspector Comment					
Erosion caused by vehicles and runoffs from rain.

View of the erosion on the waterward side of the levee looking upstream.  
Spring 2016.

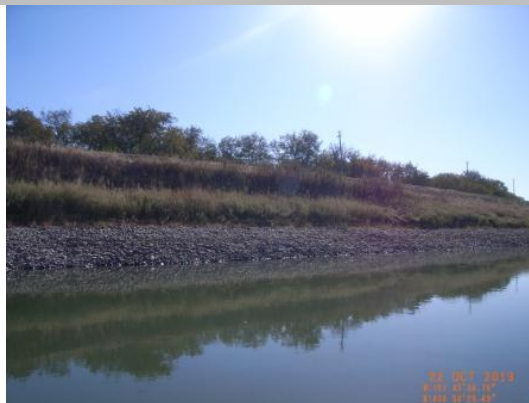
Photo 1 of 1 : SP\_2016\_RD1500\_189\_3\_20160304\_00003.jpg

LM Start	8.33	Rating **	M	Issue No.	3
LM End	8.47	Issue Type +	Ma	Location *	WS
Category	Supplemental			GPS Latitude/Longitude	
				Start	End
Item	2015 USACE Erosion Survey, DRAFT			38.839546 °	38.840347 °
				-121.729591 °	-121.726857 °
DWR ID	DWR_RD1500_01_s _ 2016_3				
Comment Code					
Inspector Comment					
1997 - Damage to cobble revetment on top left bank and toe damage. 2004 - Site is pretty minor. 2010 - Cobbles continue to deteriorate. 2011 - Minor new erosion at the toe. 2013 - Might be able to shorten due to deposition. 2015: Site shortened, downstream end has plenty of berm and deposited material, well vegetated. [2015 Site ID: SAC_92-8_L]

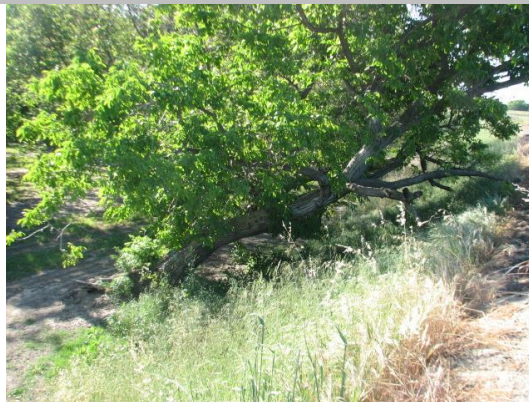
Photo 1 of 3 : SP\_2016\_RD1500\_189\_1344\_20160304\_00099.jpg

LM Start	8.92	Rating **	A/W	Issue No.	1344
LM End	8.92	Issue Type +	Ma	Location *	LS
Category	Earthen Levee			GPS Latitude/Longitude	
				Start	End
Item	Vegetation			38.845076 °	38.845076 °
				-121.728301 °	-121.728301 °
DWR ID	DWR_RD1500_01_s _ 2014_1344				
Comment Code					
V7 : Trees / Woody Vegetation					
Inspector Comment

The walnut tree at the toe has fallen. The roots are exposed and the branches are holding it up. Spring 2014

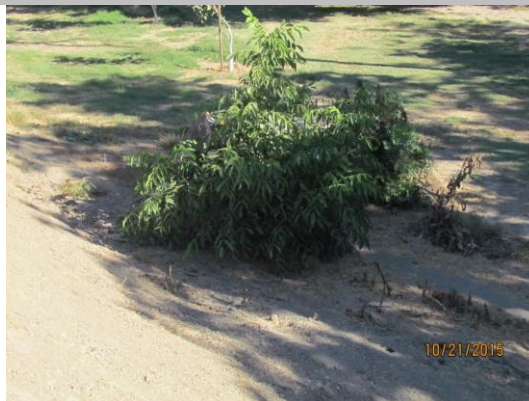
Photo 2 of 3 : SP\_2016\_RD1500\_189\_1344\_20160304\_00100.jpg

The walnut tree has been trimmed but still remains at the landward toe of the levee. Fall 2015.

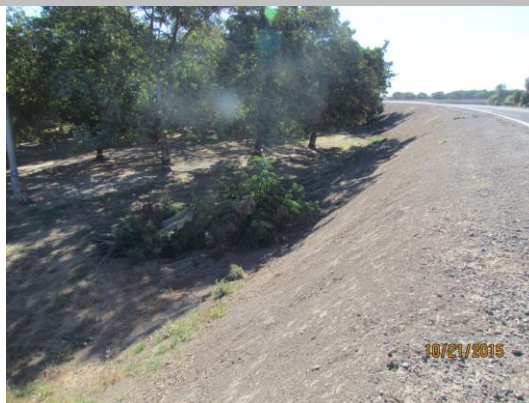
Photo 3 of 3 : SP\_2016\_RD1500\_189\_1344\_20160304\_00101.jpg

Perspective view of the walnut tree on the landward side of the levee looking downstream. Fall 2015.

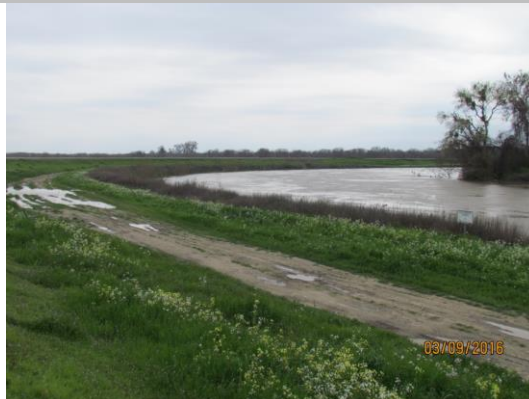
Photo 1 of 2 : SP\_2016\_RD1500\_189\_74\_20160317\_00267.jpg

View of the revegetation site along the edge of the berm on the waterward side of the levee looking downstream. Spring 2016.

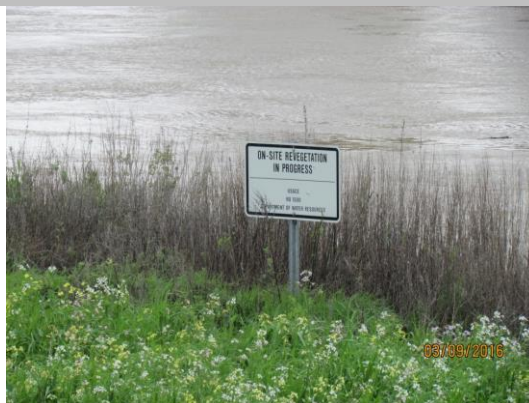
Photo 2 of 2 : SP\_2016\_RD1500\_189\_74\_20160317\_00268.jpg

Sign for the revegetation site by USACE.

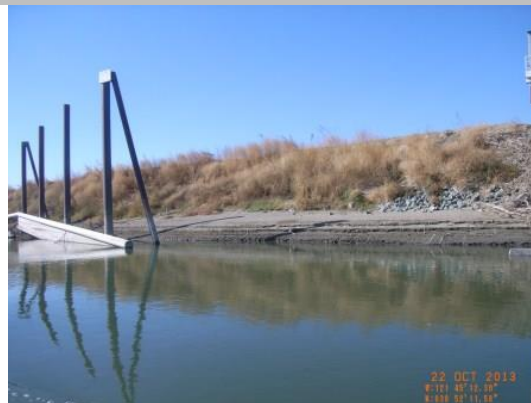
Photo 1 of 1 : SP\_2016\_RD1500\_189\_1\_20160304\_00001.jpg

LM Start	11.99	Rating **	A/W	Issue No.	1
LM End	12.26	Issue Type +	Ma	Location *	WS
Category	Supplemental			GPS Latitude/Longitude	
				Start	End
Item	2015 USACE Erosion Survey, DRAFT			38.870474 °	38.869139 °
				-121.752237 °	-121.757108 °
DWR ID	DWR_RD1500_01_s_2016_1				
Comment Code					
Inspector Comment					
2000 - Vertical Modesto Formation bank with mass failure. 2003 - Upstream end has some new bank retreat. 2004 - Upstream end is worse. 2006 - Some new erosion, mainly on the steep slope and scarps. (Pumping station is not part of the erosion site.) 2010 - Some new erosion and deposition at upstream end, definite encroachments. 2011 - Minor new erosion at the toe. 2015: Site removed, sufficient berm width. [2015 Site ID: SAC_96-2_L]

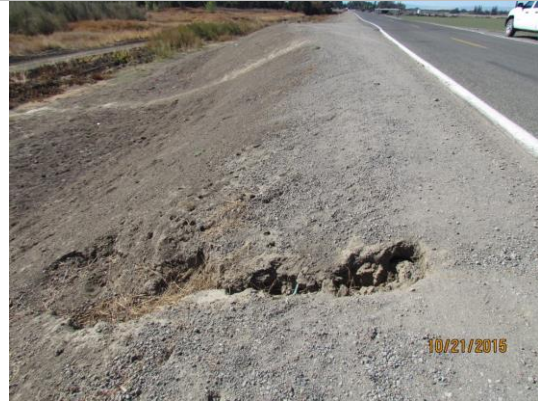
Photo 1 of 1 : SP\_2016\_RD1500\_189\_118\_20160304\_00081.jpg

LM Start	12.57	Rating **	M	Issue No.	118
LM End	12.57	Issue Type +	Ma	Location *	WS
Category	Earthen Levee			GPS Latitude/Longitude	
				Start	End
Item	Erosion / Bank Caving			38.867108 °	38.867108 °
				-121.761498 °	-121.761498 °
DWR ID	DWR_RD1500_01_f_2015_118				
Comment Code					
E2 : Schedule repair of erosion site prior to the next inspection.					
Inspector Comment

View of the erosion on the waterward side of the levee looking upstream. Fall 2015.

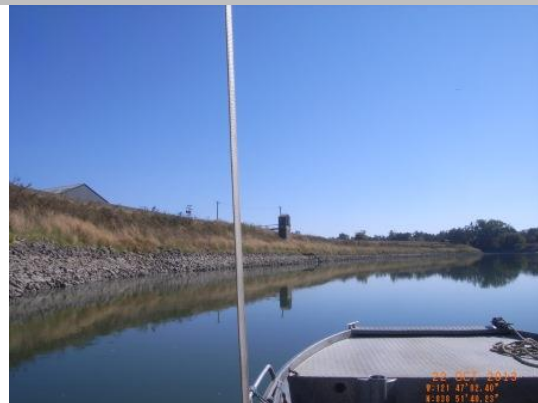
Photo 1 of 1 : SP\_2016\_RD1500\_189\_10\_20160304\_00010.jpg

LM Start	13.98	Rating **	M	Issue No.	10
LM End	14.26	Issue Type +	Ma	Location *	WS
Category	Supplemental			GPS Latitude/Longitude	
				Start	End
Item	2015 USACE Erosion Survey, DRAFT			38.857239 °	38.861899 °
				-121.783771 °	-121.784057 °
DWR ID	DWR_RD1500_01_s_2016_10				
Comment Code					
Inspector Comment					
1997 - Intermittent toe failure of the hand placed riprap; failure of toe materials. 2015: No observed changes. [2015 Site ID: SAC_99-0_L]

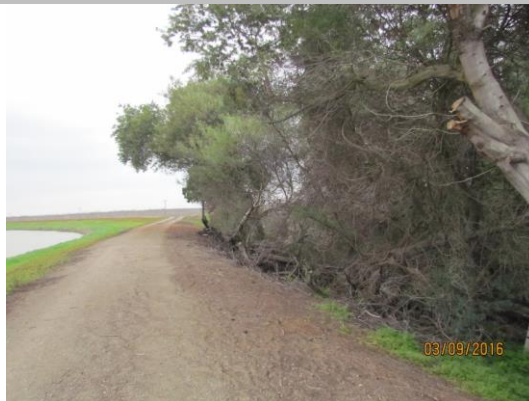
Photo 1 of 2 : SP\_2016\_RD1500\_189\_77\_20160317\_00274.jpg

View of the trees on the landward side of the levee looking upstream. Spring 2016.

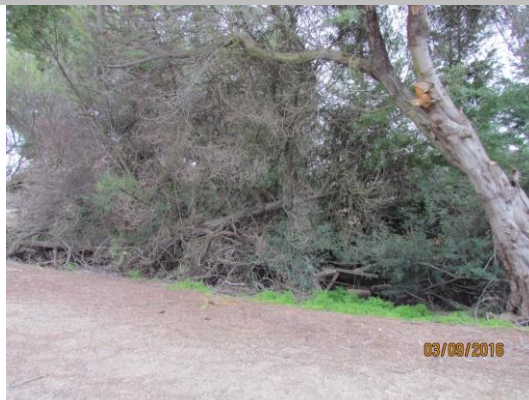
Photo 2 of 2 : SP\_2016\_RD1500\_189\_77\_20160317\_00273.jpg

Trees block visibility on the landward slope. Spring 2016.

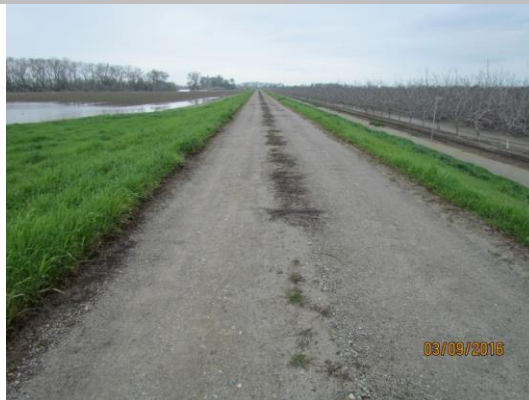
Photo 1 of 1 : SP\_2016\_RD1500\_189\_159\_20160317\_00275.jpg

LM Start	15.34	Rating **	M	Issue No.	159
LM End	17.29	Issue Type +	Ma	Location *	CR
Category	Earthen Levee			GPS Latitude/Longitude	
				Start	End
Item	Crown Surface / Depressions / Rutting			38.868748 °	38.887612 °
				-121.797371 °	-121.807911 °
DWR ID	DWR_RD1500_01_s _ 2016_159				
Comment Code					
C3 : Add appropriate gravel or road base. Grade and compact.					
Inspector Comment

View of the crown of the levee looking upstream. Spring 2016.

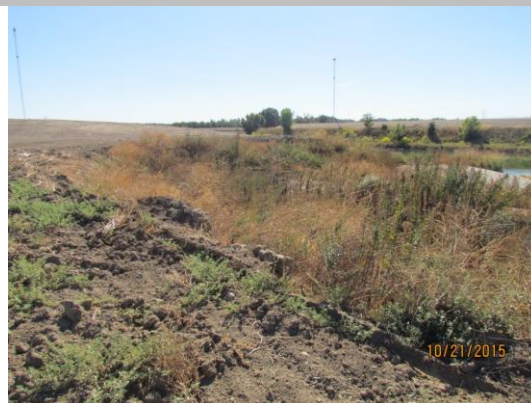
Photo 1 of 2 : SP\_2016\_RD1500\_189\_51\_20160304\_00042.jpg

Looking downstream at the embankment erosion. Fall 2015.

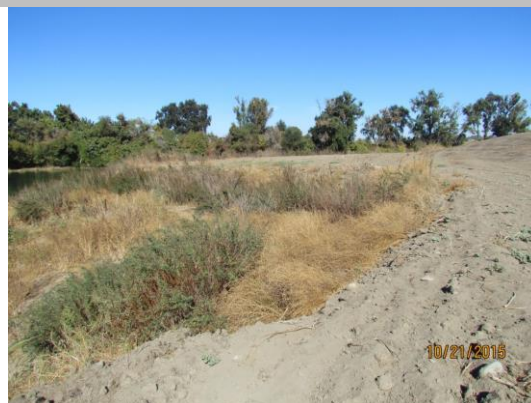
Photo 2 of 2 : SP\_2016\_RD1500\_189\_51\_20160304\_00043.jpg

Looking upstream at the same embankment erosion. Fall 2015.

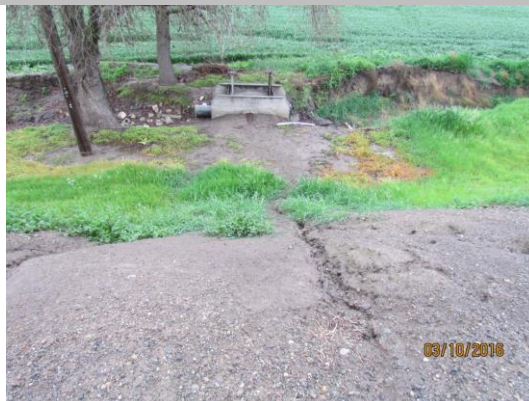
Photo 1 of 2 : SP\_2016\_RD1500\_189\_165\_20160317\_00280.jpg

View of the erosion on the landward side of the levee caused by runoffs. Spring 2016.

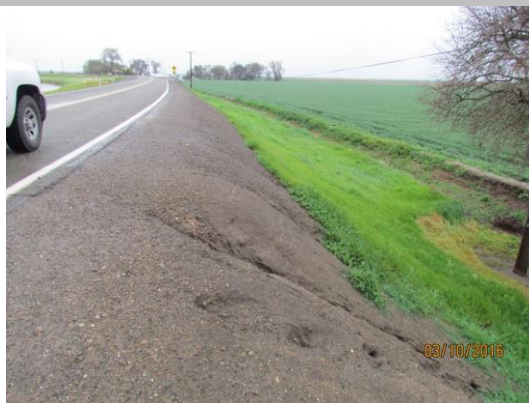
Photo 2 of 2 : SP\_2016\_RD1500\_189\_165\_20160317\_00278.jpg

Perspective view of the erosion looking upstream. Spring 2016.

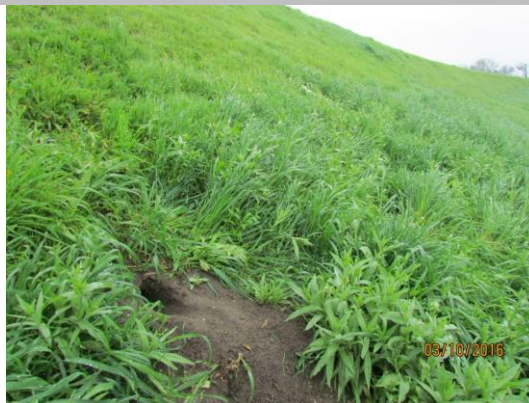
Photo 1 of 1 : SP\_2016\_RD1500\_189\_102\_20160317\_00284.jpg

View of rodent hole on the landward side of the levee looking upstream. Spring 2016.

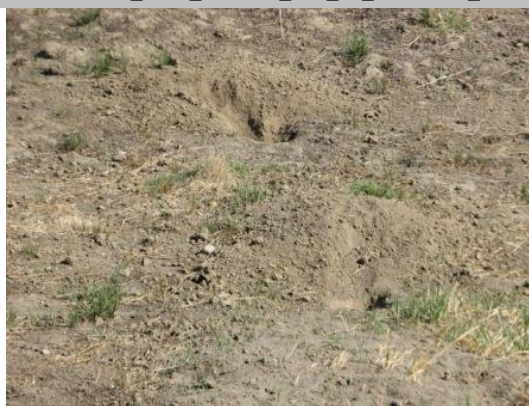
Photo 1 of 2 : SP\_2016\_RD1500\_189\_69\_20160304\_00048.jpg

Multiple rodent burrows on landside slope. Fall 2013

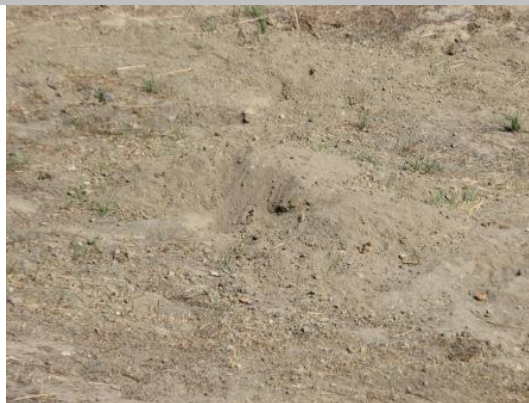
Photo 2 of 2 : SP\_2016\_RD1500\_189\_69\_20160304\_00049.jpg

A rodent burrow on the landside Fall 2013

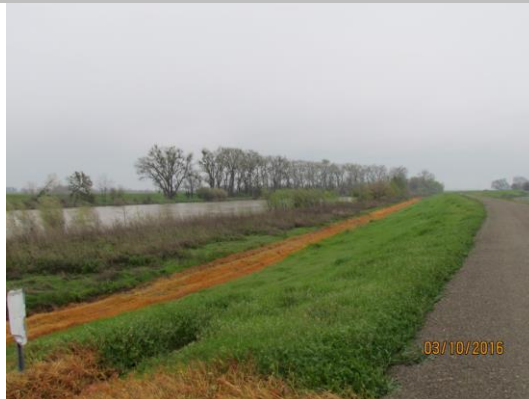
Photo 1 of 2 : SP\_2016\_RD1500\_189\_84\_20160317\_00288.jpg

View of the revegetation site on the waterward side of the levee looking upstream. Spring 2016.

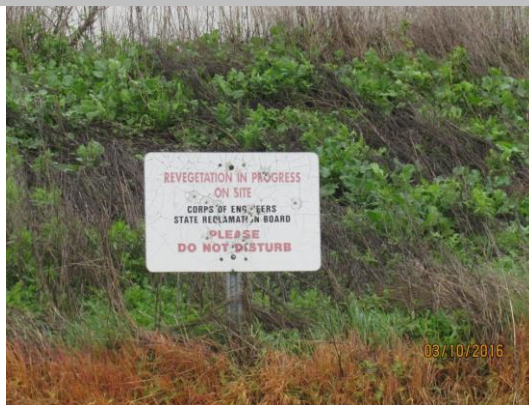
Photo 2 of 2 : SP\_2016\_RD1500\_189\_84\_20160317\_00289.jpg

Sign for the revegetation site. Spring 2016.

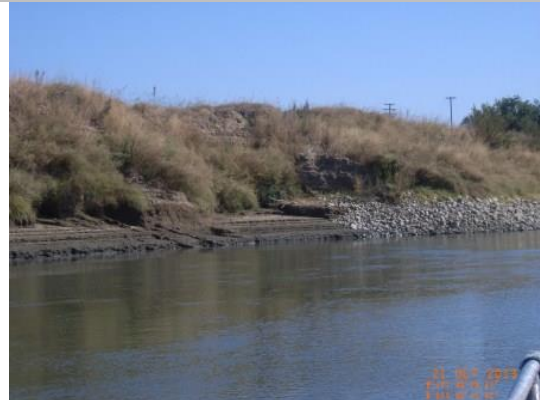
Photo 1 of 1 : SP\_2016\_RD1500\_189\_15\_20160304\_00015.jpg

Comment Code					
Inspector Comment					
2003 - New sedimentation and some new small toe scallops at the upstream end; downstream end has some new erosion. 2004 - Some new erosion at the toe and upper bank and some small new rotational failures (mainly minor, except at the downstream end). 2007 - Some new slumps. 2009 - Some new scallops and site was extended upstream. 2010 - New deposition along upstream end of site, however there is also new erosion throughout the site. Site seems to be worsening, and eroding fast. Large habitat for bank swallows. 2011 - Some new minor erosion. 2012 - Minor new erosion. 2015: No observed changes. [2015 Site ID: SAC_116-5_L]

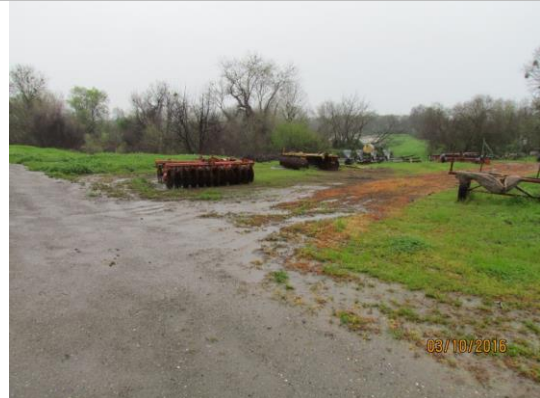
Photo 1 of 1 : SP\_2016\_RD1500\_190\_12\_20160317\_00014.jpg

View of the equipment on the levee crown looking upstream. Spring 2016.

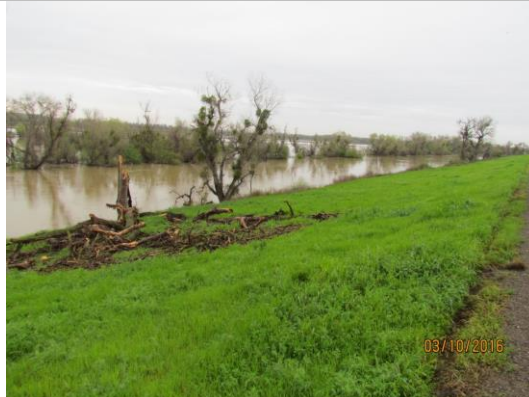
Photo 1 of 1 : SP\_2016\_RD1500\_190\_19\_20160317\_00013.jpg

View of the fallen tree on the waterward side of the levee looking downstream. Spring 2016.

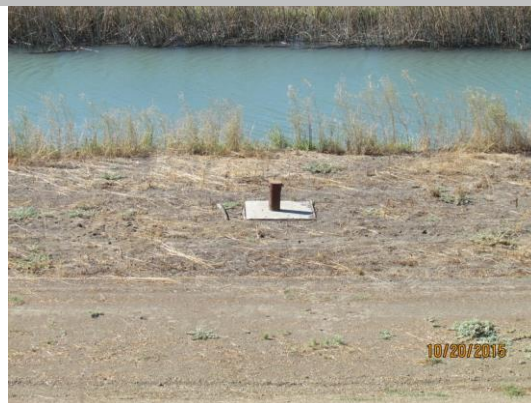
Photo 1 of 1 : SP\_2016\_RD1500\_190\_4\_20160304\_00002.jpg

View of the relief well at historical boil 12. Fall 2015.

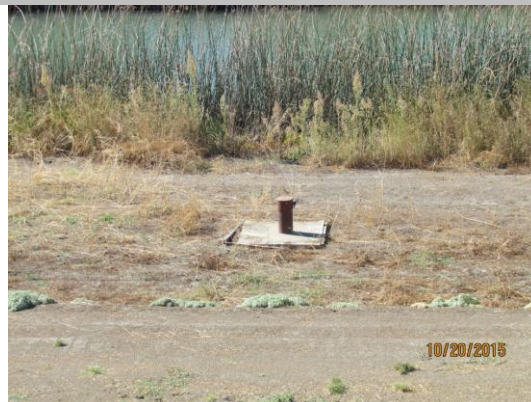
Photo 1 of 1 : SP\_2016\_RD1500\_190\_11\_20160304\_00003.jpg

A relief well at historical boil 16. Fall 2015.

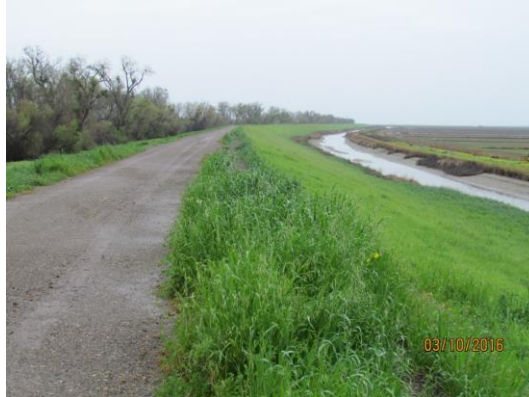
Photo 1 of 1 : SP\_2016\_RD1500\_190\_2\_20160317\_00009.jpg

View of the vegetation on the landward side of the levee looking downstream. Spring 2016.

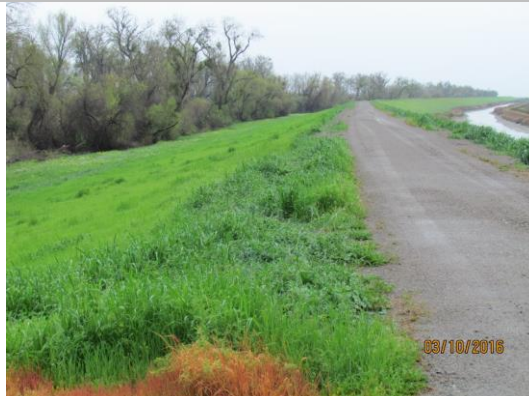
Photo 1 of 1 : SP\_2016\_RD1500\_190\_3\_20160317\_00010.jpg

View of the vegetation on the waterward side of the levee looking downstream. Spring 2016.

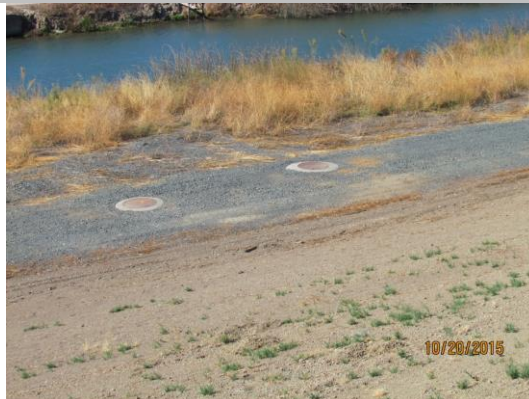
Photo 1 of 2 : SP\_2016\_RD1500\_190\_13\_20160304\_00006.jpg

Two of four drains on the landward side of the levee. Fall 2015.

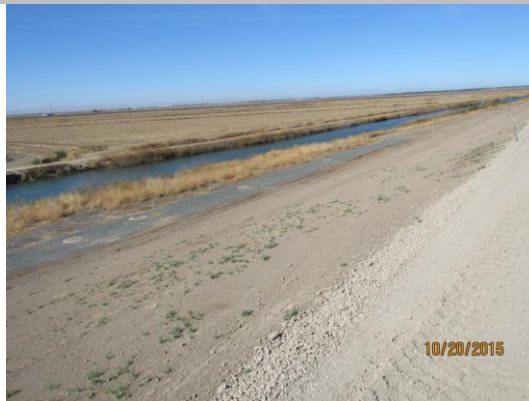
Photo 2 of 2 : SP\_2016\_RD1500\_190\_13\_20160304\_00007.jpg

View of the 4 drains at the levee toe on the landward side. Fall 2015.

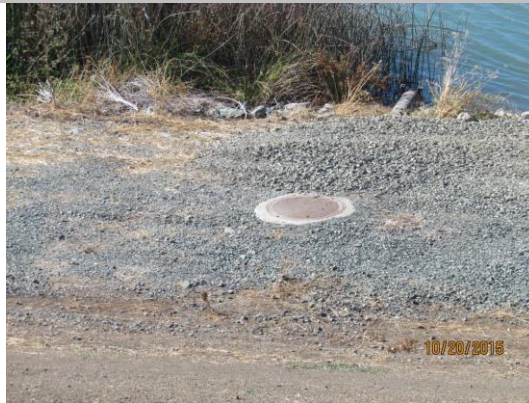
Photo 1 of 1 : SP\_2016\_RD1500\_190\_15\_20160304\_00008.jpg

View of the toe drainage at the landward toe berm. Fall 2015.

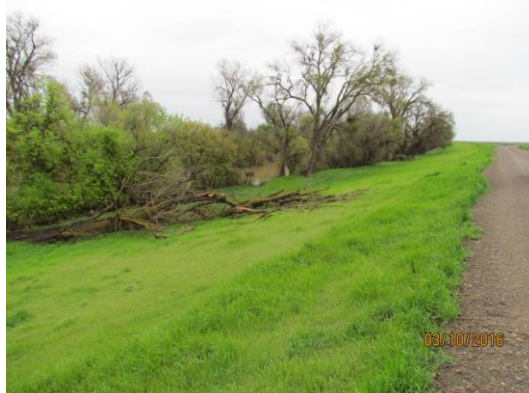
Photo 1 of 1 : SP\_2016\_RD1500\_190\_6\_20160317\_00012.jpg

View of the tree on the waterward side of the levee looking downstream.  
Spring 2016.

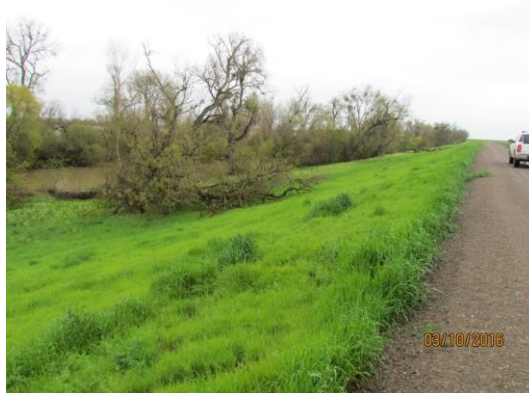
Photo 1 of 1 : SP\_2016\_RD1500\_190\_5\_20160317\_00011.jpg

View of the tree on the waterward side of the levee looking downstream.  
Spring 2016.
